KLO-02-001

Mission STS-104
OV-104 Flight 24
Thermal Protection System
Post-Flight Assessment

March 2002

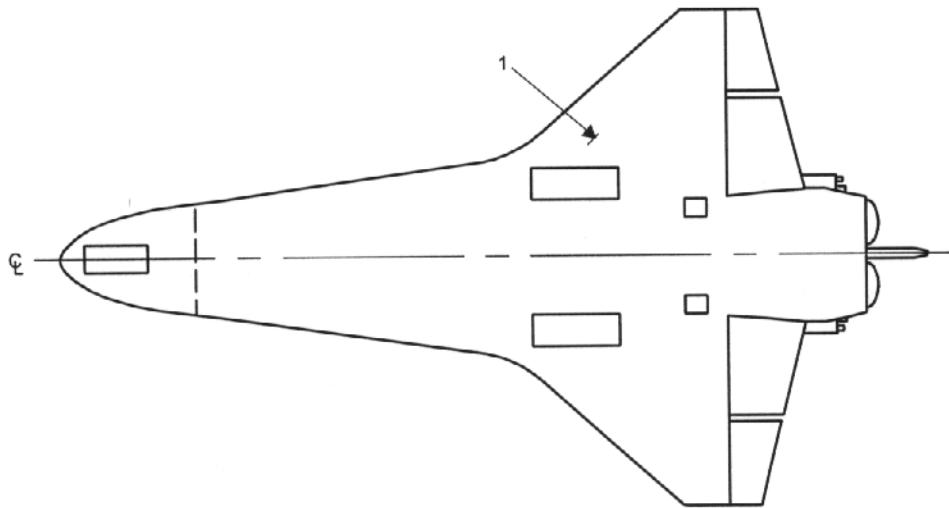
Table 6. Protruding Gap Filler Locations

LOCATION NUMBER	X	Y	ADJACENT TILE NUMBERS	AMOUNT PROTRUDED
1	1133.54	216.38	V070-191005-036 AND -069	0.200"
